# ConocoPhillips Mississippi River Pipeline Release

August 6 - October 3, 2003

presented by Tim Ganz, former State On-Scene Coordinator,  
Missouri Department of Natural Resources  
Environmental Emergency Response Section

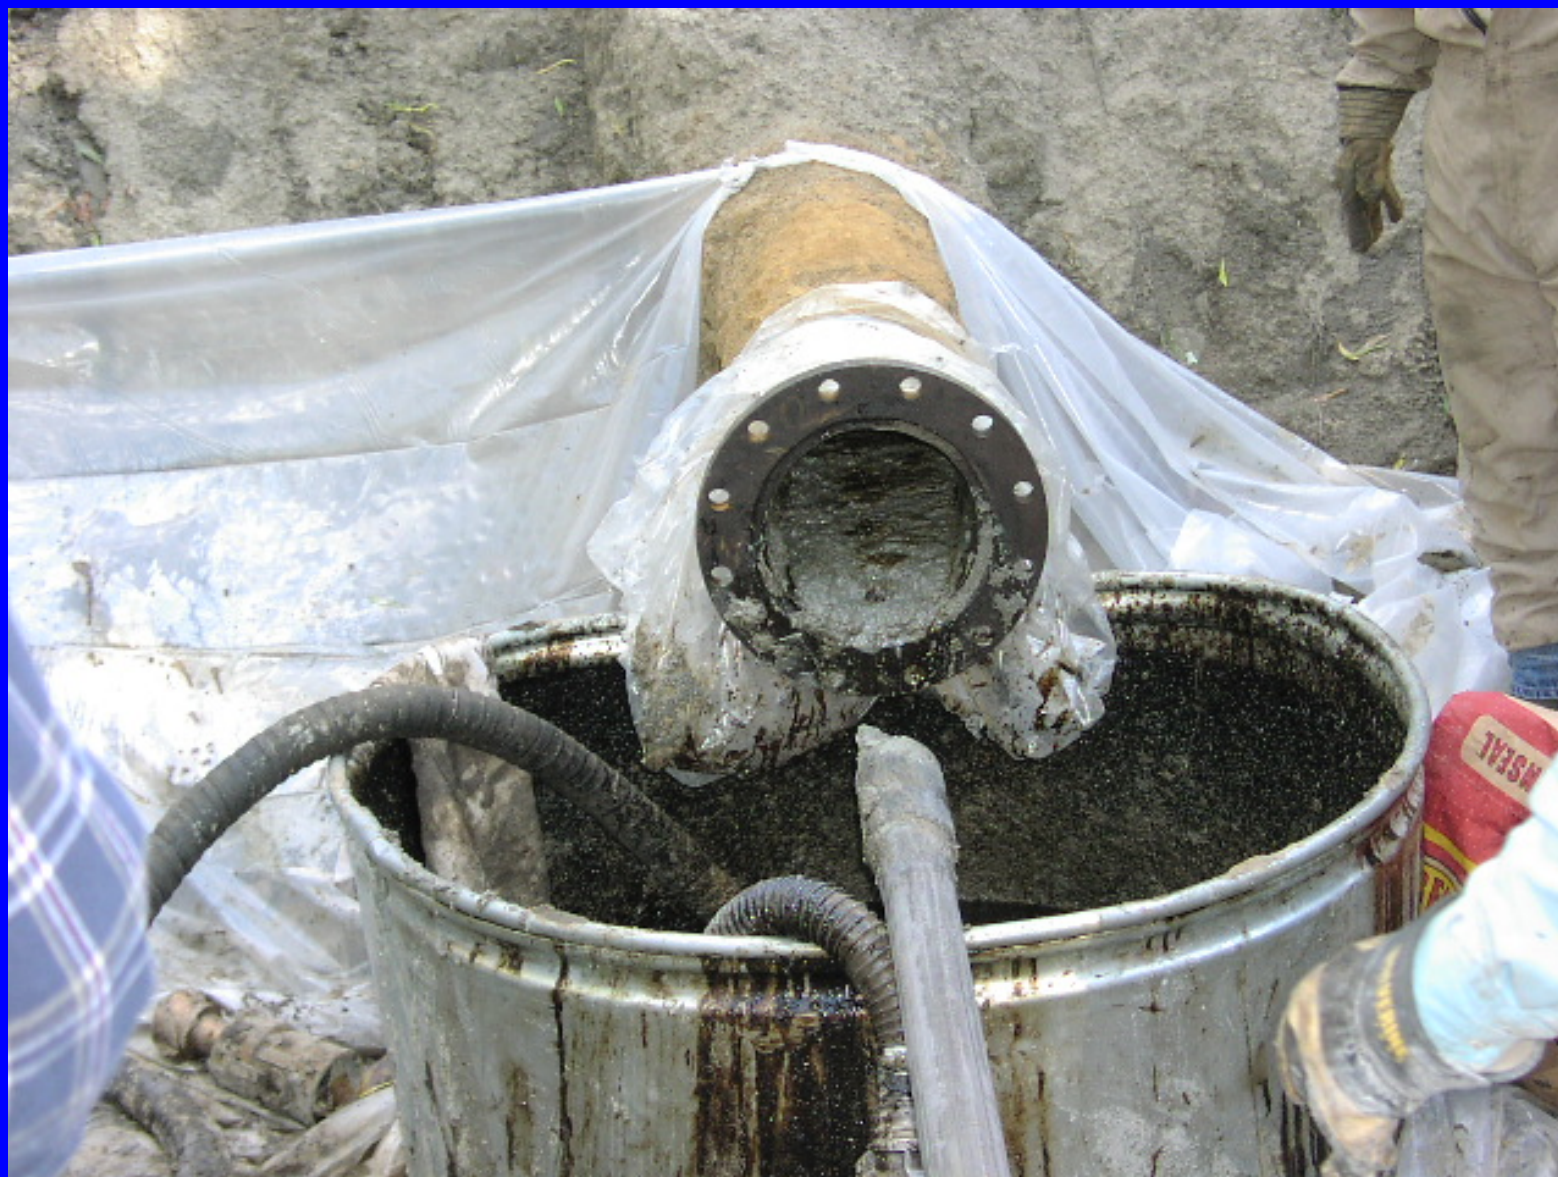
South line filled with drilling mud

- Drilling mud was pumped into the Missouri side of the south line to complete the filling of the line
- An additional 5 barrels of crude were recovered from this process
- Line permanently capped – abandonment complete
- Same process utilized on the north line

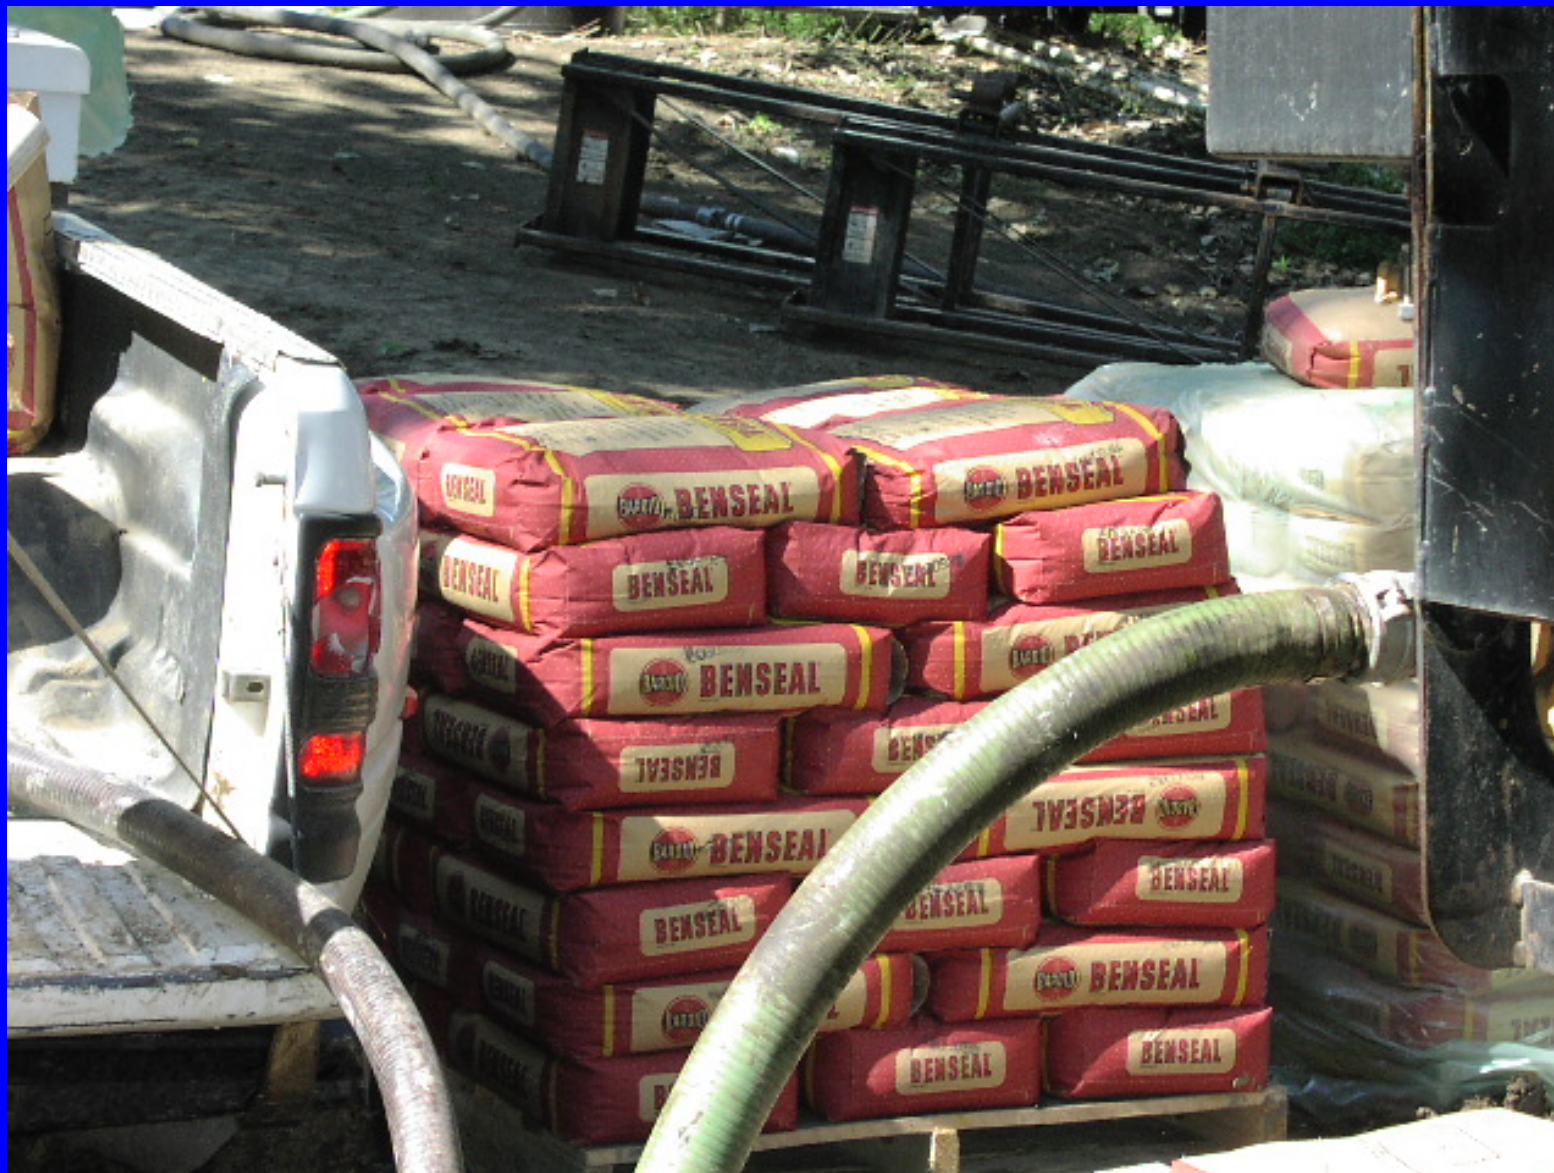
Drilling mud prior to mixing and inserting in the lines

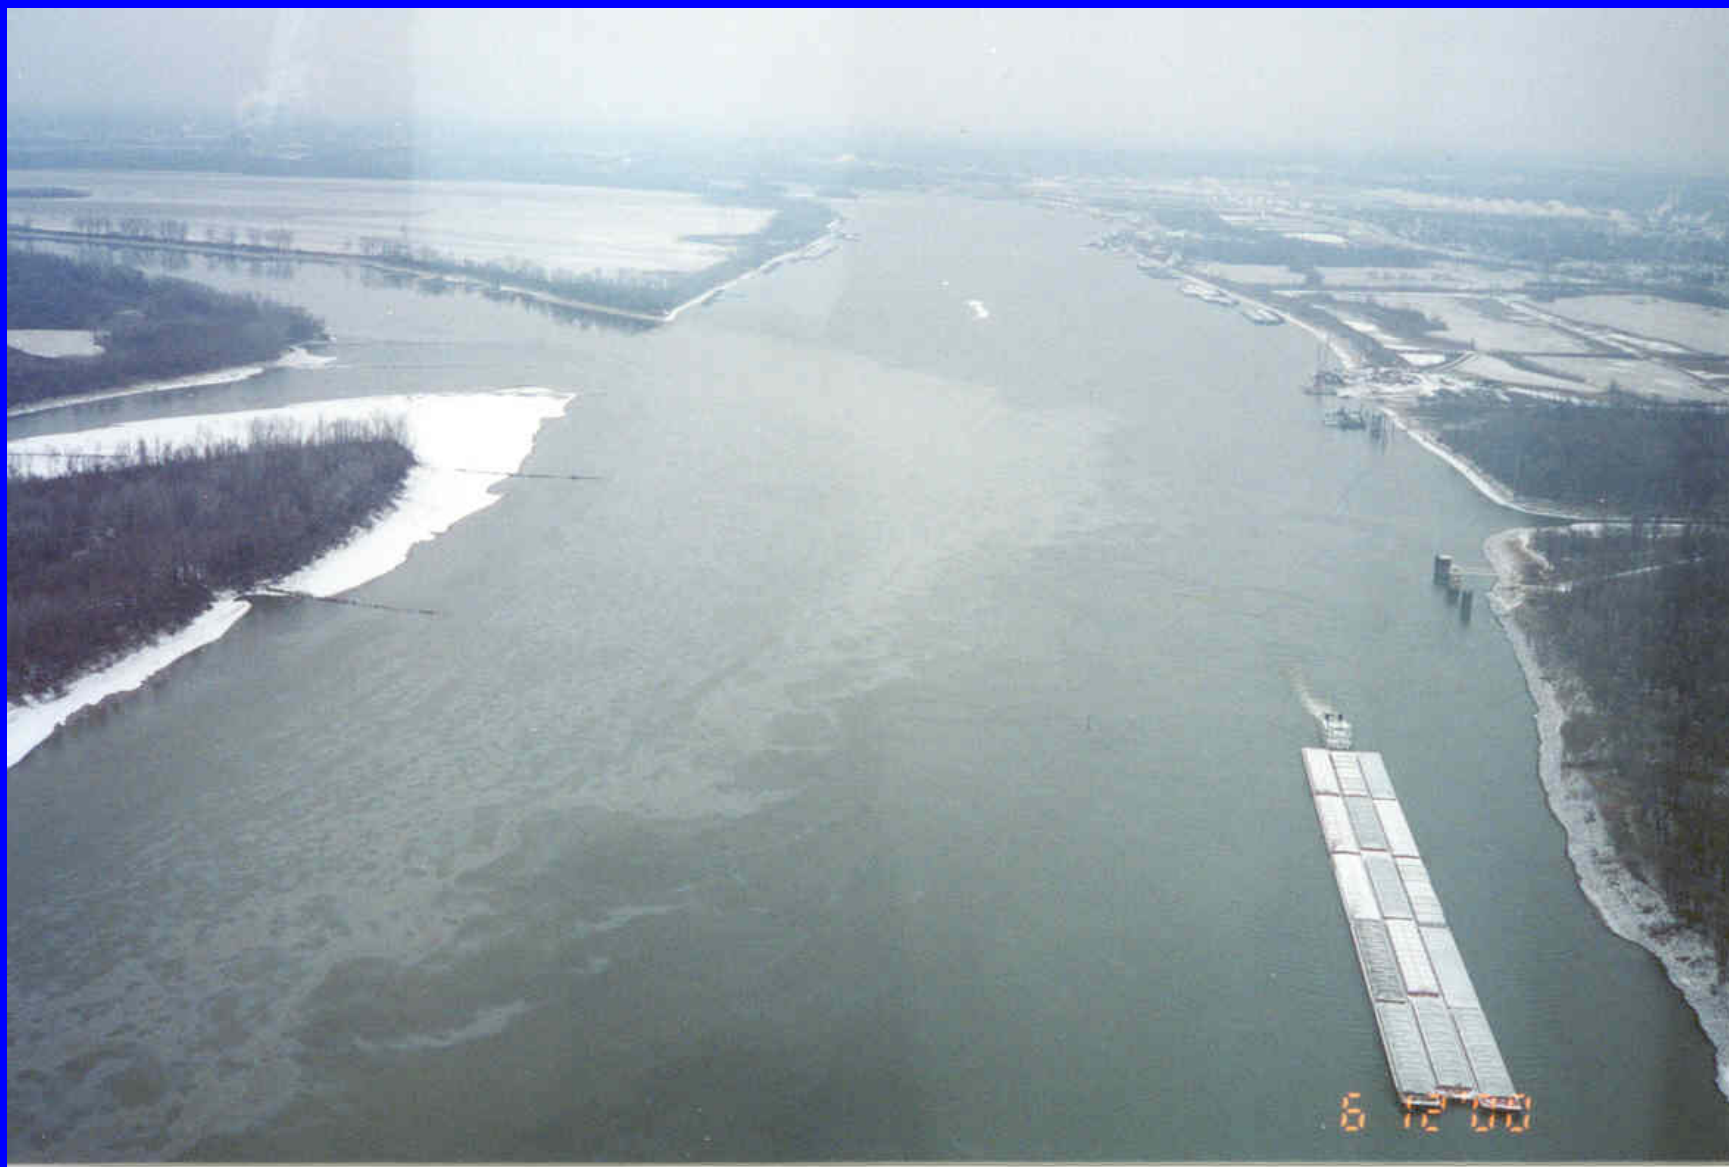
## Sheen at confluence of Missouri and Mississippi Rivers
